RE: Response to October 9, 2020 USACE Comment Letter, Proposed Big Hollow Wetland Mitigation Bank Project, Sauk County, WI

On behalf of Big Hollow Wetland, LLC, Heartland Ecological Group, Inc. ("Heartland") is providing a summary response to the comments provided in the USACE letter submitted to the bank Sponsor dated October 9, 2020 in response to the review of the draft MBI for the proposed Big Hollow Wetland Mitigation Bank project. The comments will be incorporated into the draft MBI for final review once we reach resolution on addressing the comments. The responses to the comments follow the numbering and order presented in the Corps letter.

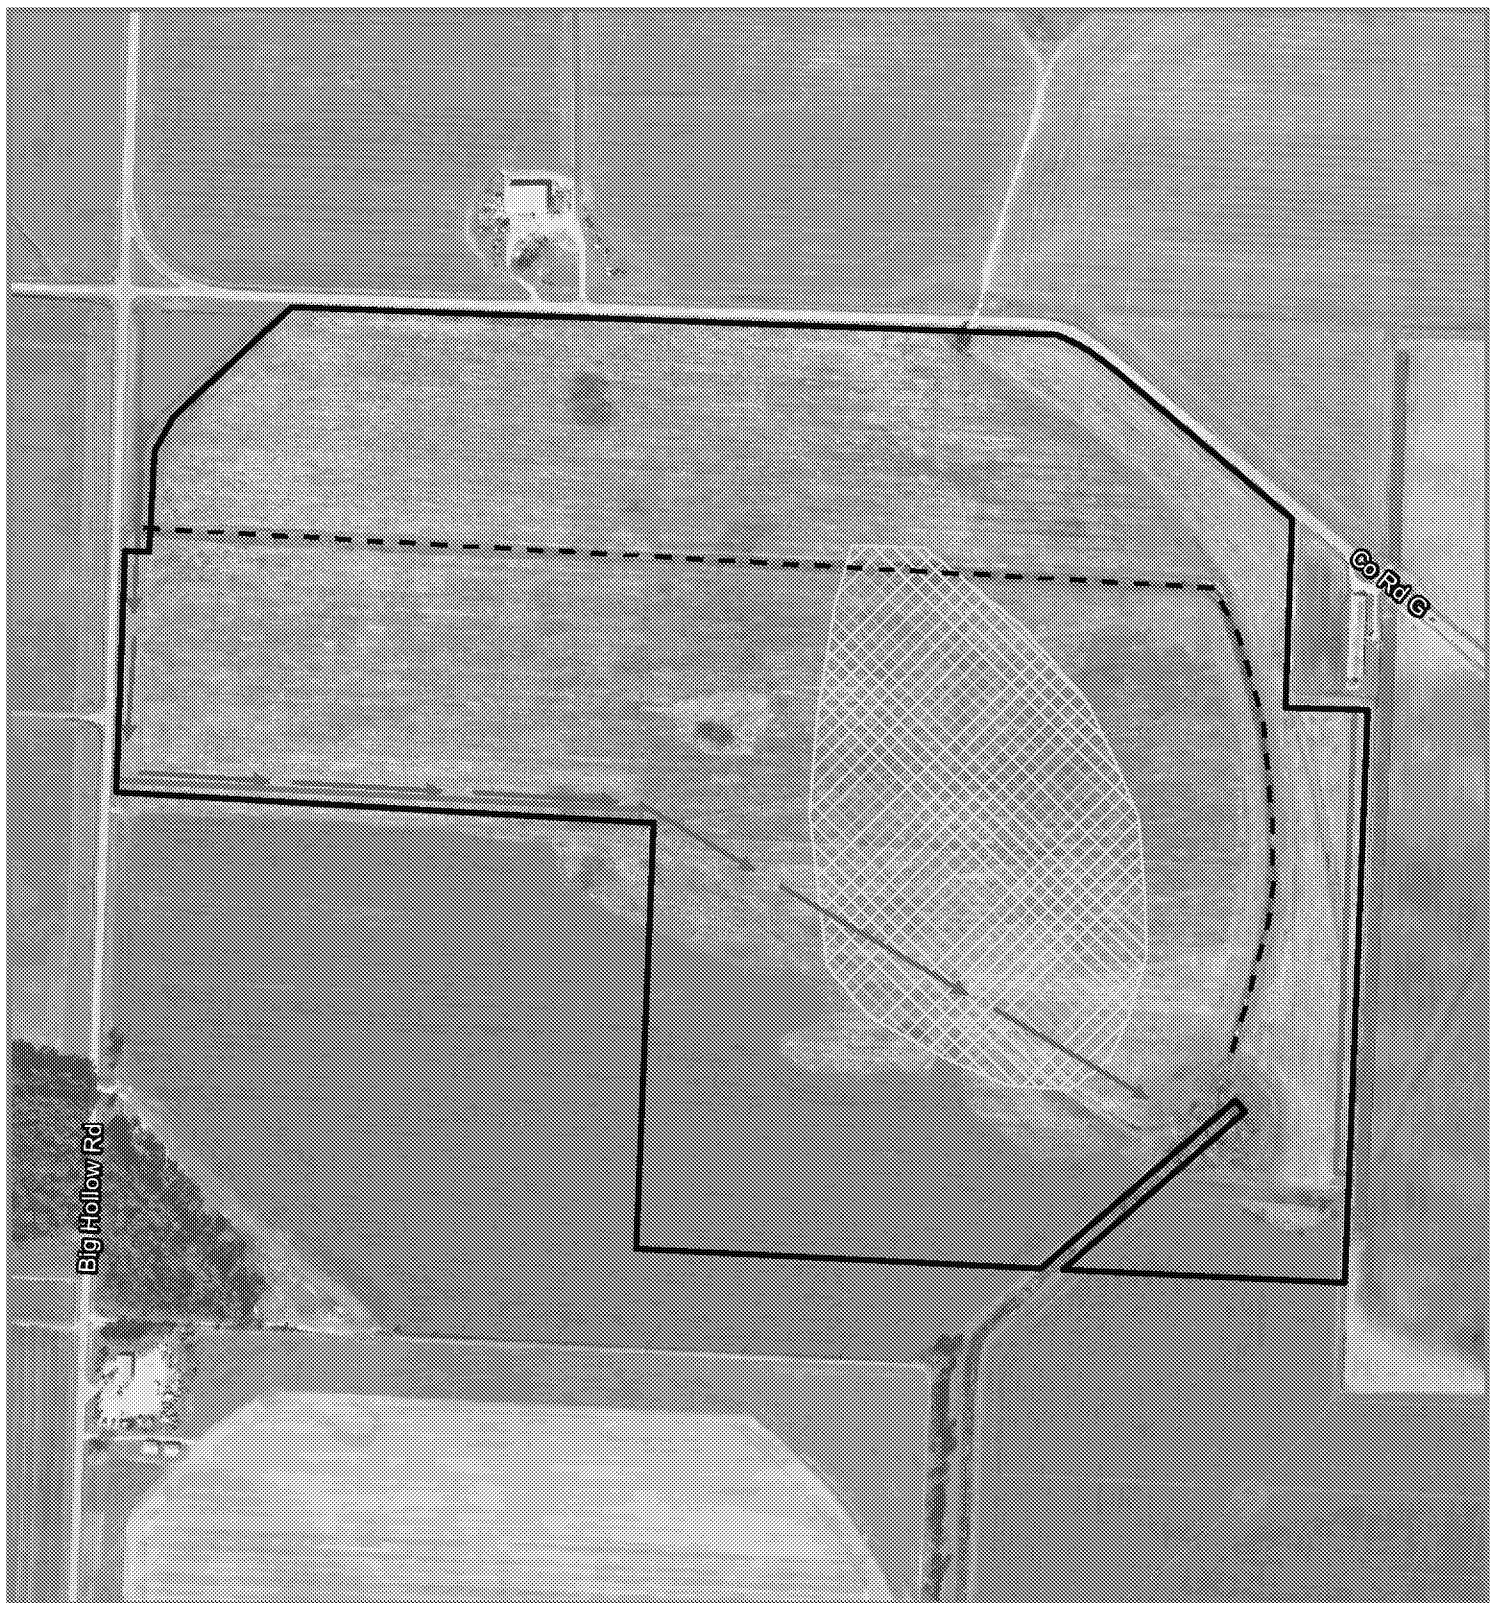
- Mit. Bank Area (192.72 ac)
- Existing Ditch to be Filled
- Proposed Flowpath
- Proposed Scrapes (30.81 ac)
- Proposed Berms

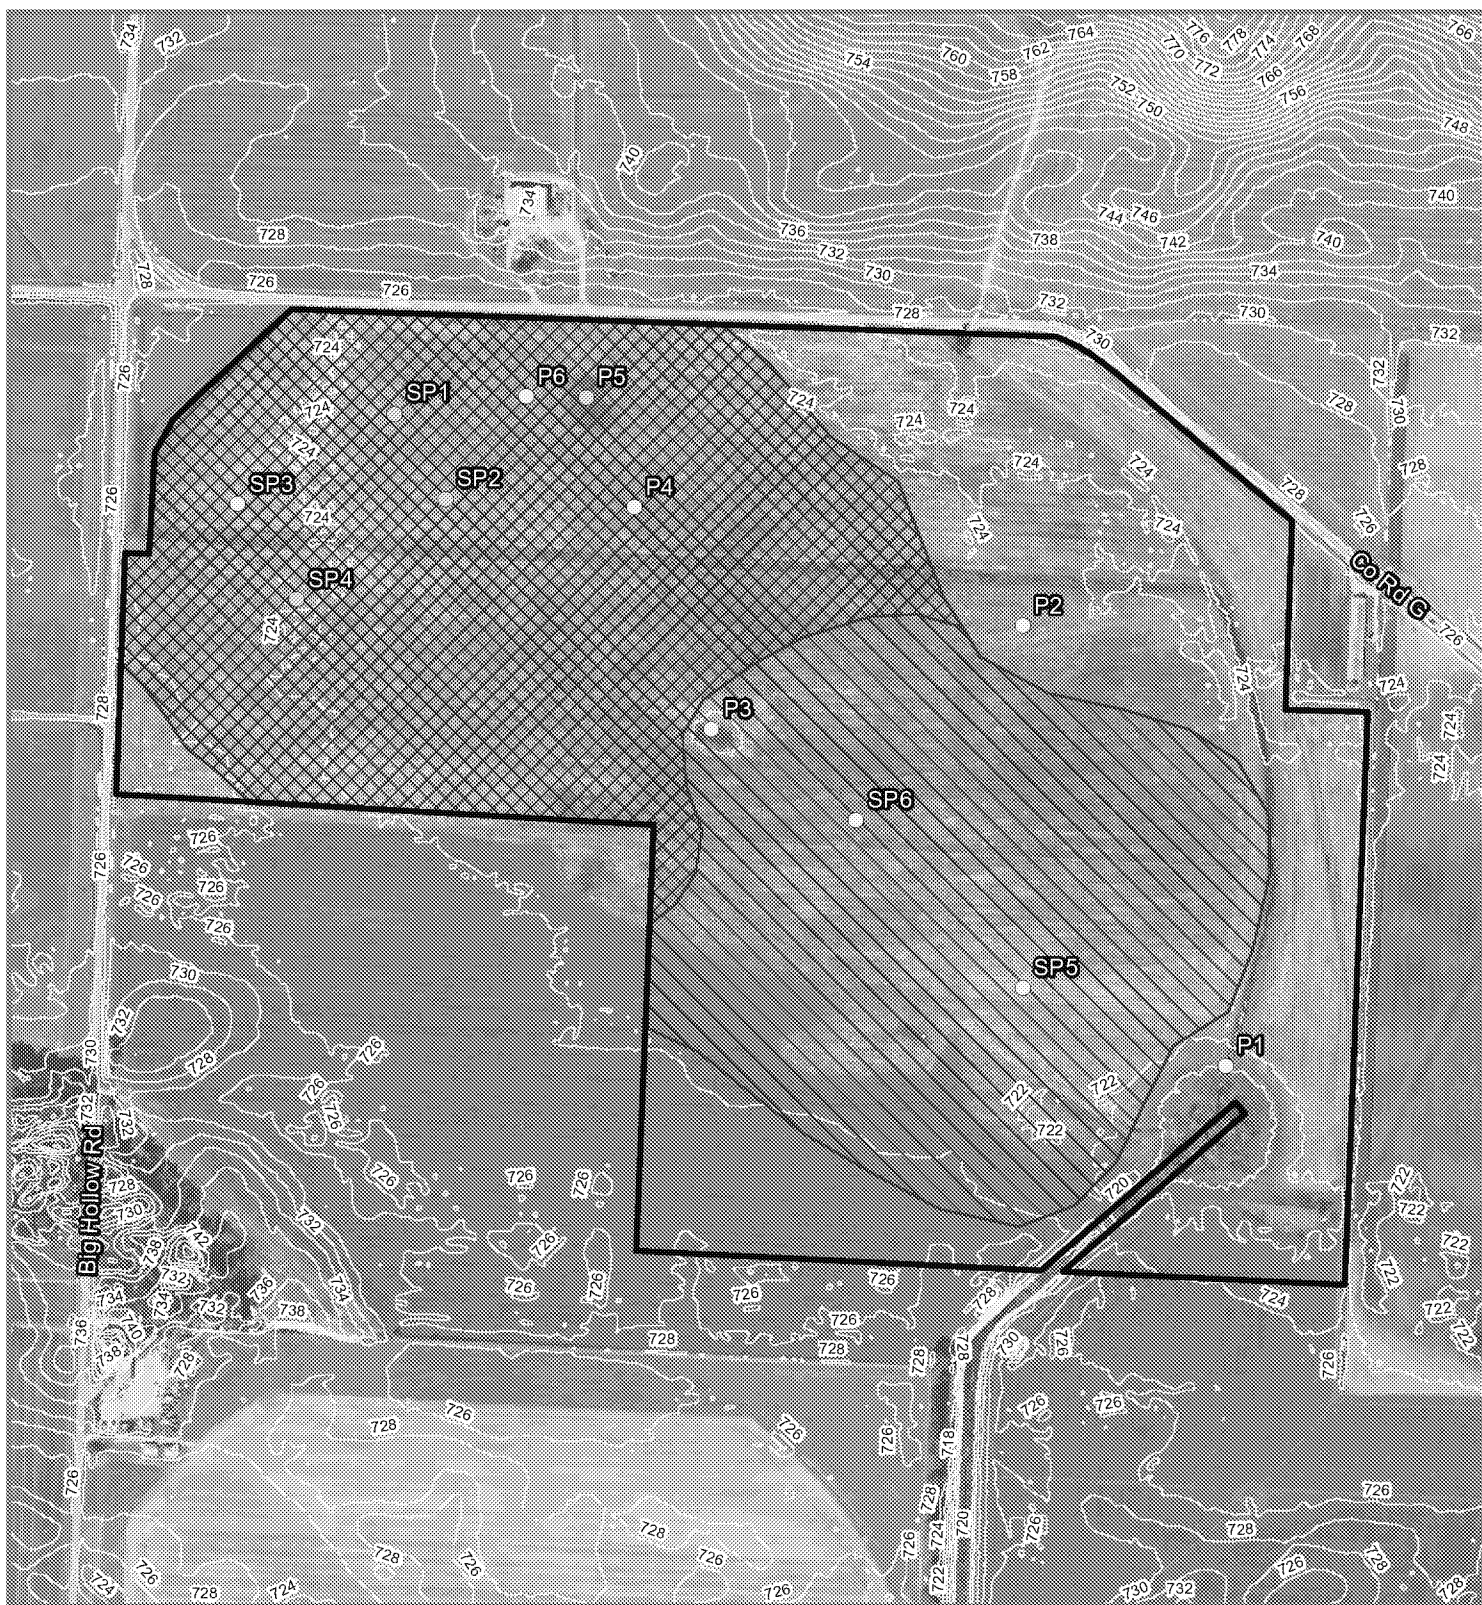
evidence of seasonally high-water tables. Nonetheless, a hydric soil boundary was estimated based on the results of the soil evaluation, considering topography and hydrology (Figure 12).

Mit. Bank Area (192.72 ac)
 Sauk Co 2' Contours

Soil Sample Points

In conjunction with USACE and WDNR staff, Heartland completed a soil evaluation in the early fall of 2020 to identify and map hydric and nonhydric soils. An additional six (6) soil profiles were evaluated within the proposed wetland restoration portions of the site (Soil Data Sheets attached). All soil profiles that were evaluated showed indicators of seasonally high-water tables near the surface such as redoximorphic features and depleted or nearly depleted matrices. This was consistent with soils evaluated during the wetland determination study as well. Soil profiles that met an indicator of hydric soils were limited to the northwestern portion of the wetland restoration areas. Soil profiles that did not meet a hydric soil indicator were very marginal in nature and did not meet hydric soil indicators based on very minor technicalities. For example, at both SP-3 and SP-5 the depleted matrix present was only 2 inches too deep to meet A11. Depleted Below Dark Surface. Saturated soils and a water table were present within 24 inches of the soil surface. Soils evaluated at SP-6 again marginally do not meet a number of hydric soil indicators by minor technicalities but otherwise reflects a poorly drained soil with a seasonally high-water table. Saturated soils were present within 12 inches of the surface. It is apparent that the entire wetland restoration areas support a mosaic of hydric and marginally nonhydric soils given the lack of relief across the site and
